## **Heavy Vehicle Wheel Detachment FERA Seminar**

Presented by Martin Dodd

11<sup>th</sup> July 2007

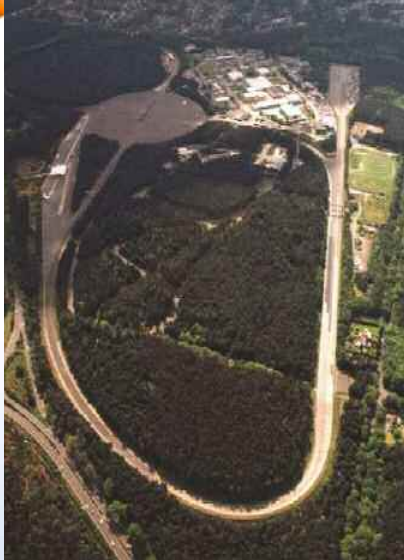
## Facilities - TRL Research Track

- **Central Area**
  - 270m diameter
  - 200m & 120m dia circles
  - Spray bars
- **Long Straight**
  - 550m long
  - 3 x 3m lanes
  - Spray bars
- **Large Loop**
  - 2km long
- **Banked Bend**
- **Small Road System**
  - Urban road conditions
  - 2.5km total length

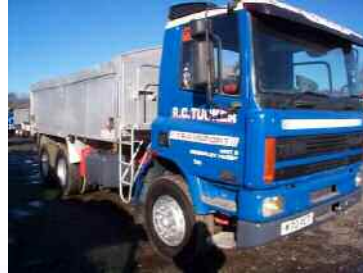
## Re-torque

- **Agreed it's necessary...but when?**
- **Track tests**
  - 6x4 tipper
- **Monitor clamp load**
  - Time
  - Distance travelled
- **Mark positions of wheel nuts**
- **Instrumented wheel studs**
  - Strain gauge and telemetry
